DDAS Accident Report

Report date: 18/01/2008	Accident number: 482
Accident time: 6:16	Accident Date: 21/08/2006
Where it occurred: Schull Mountain, Schull Village, Rasht District	Country: Tajikistan
Primary cause: Inadequate training (?)	Secondary cause: Field control inadequacy (?)
Class: Excavation accident	Date of main report: 31/08/2006
ID original source: None	Name of source: TMAC
Organisation: [Name removed]	
Mine/device: PMN AP blast	Ground condition: grass/grazing area rocks/stones
Date record created:	Date last modified: 18/01/2008
No of victims: 1	No of documents: 2

REPORT OF BOARD OF INQUIRY

INTO DEMINING ACCIDENT AT SHULL MOUNTAIN ON 21 AUGUST 2006

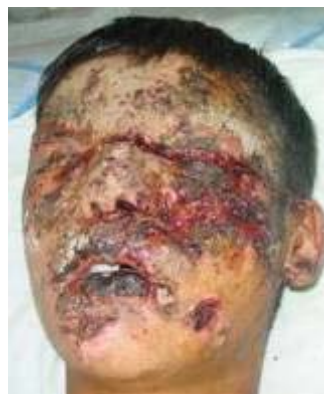
31st August 2006 below

Photographs showed one leg bandaged top to bottom, the other peppered with small fragmentation wounds at the thigh. Both hands were bandaged and bloody with lacerations of the fingers.

"Today the operator had another surgery in Russian military hospital for 1hr 30min on his eyes. No frags in his skull. I've talked with the doctor who made surgery, she said that [the Victim] lost sight in both eyes."
